Technical Service BULLETIN

POWER FRONT SEAT MOVEMENT/NOISE

'00 Avalon

BODY
B0005-01

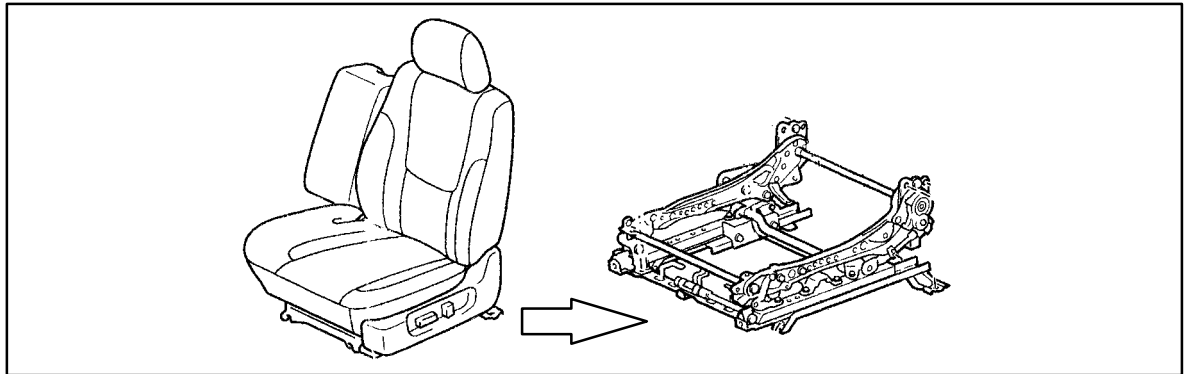
Replace the seat adjuster with the service part. Refer to the 2000 MY Avalon Repair Manual, pages BO-98 through BO-105.
