**Technical Service  
BULLETIN**

# NAVIGATION DOOR REPLACEMENT

'05 – '07 Avalon

**REVISÉD**  
**B0008-06**  
**BODY**

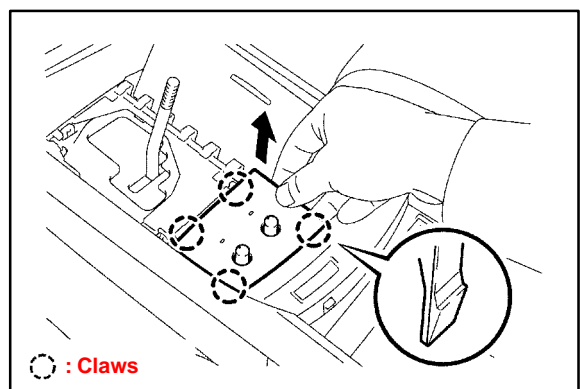
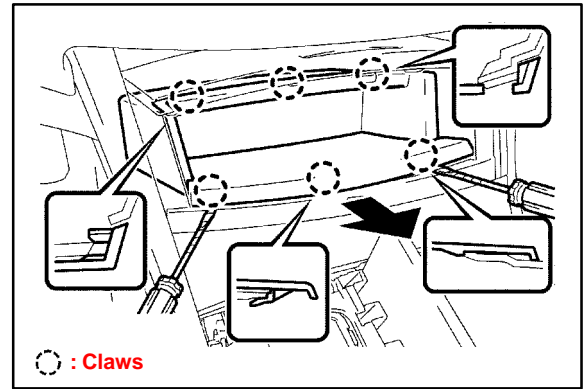
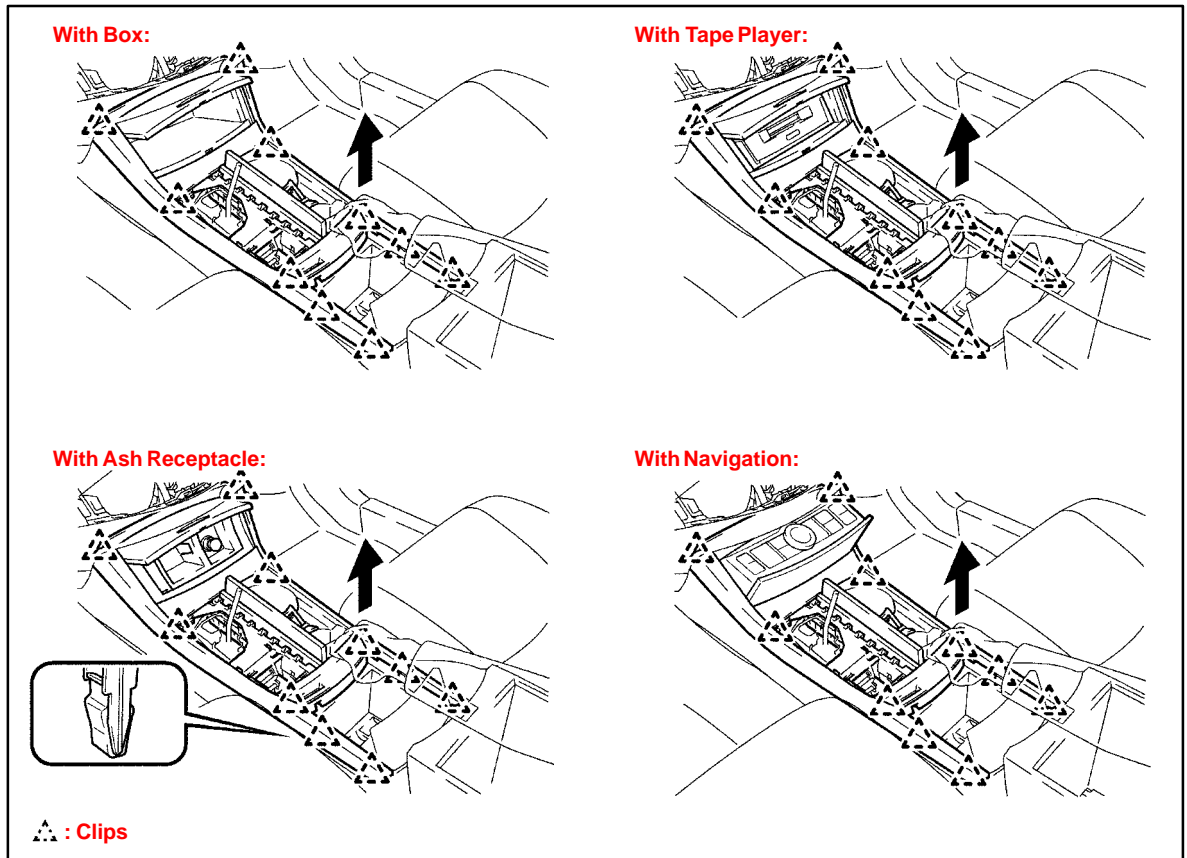
- D. Remove the upper console sub-assembly panel.
  - a. Disengage the 6 claws and remove the console upper box (with box).
  - b. Disengage the 10 clips.
  - c. Disconnect the connectors and remove the console upper panel sub-assembly.
  - d. Remove the tape player assembly (with tape player)

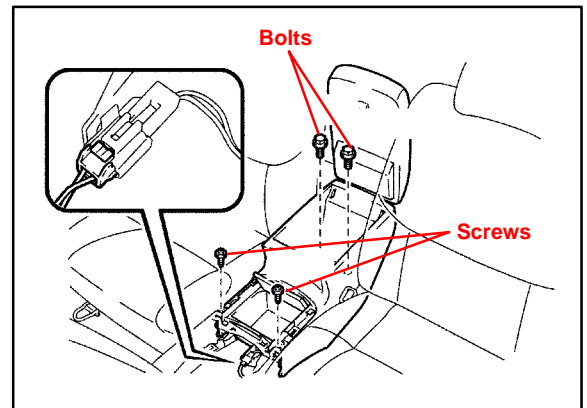
- E. Remove the console box carpet.
- F. Remove the console box assembly.
  - a. Disconnect the connector.
  - b. Remove the 2 bolts and 2 screws and then the console box assembly.

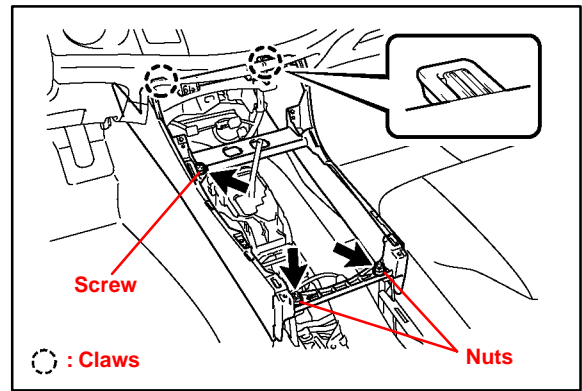
- G. Remove the console box front.
  - a. Remove the 2 nuts and screw.
  - b. Disengage the 2 claws and remove the console front box.

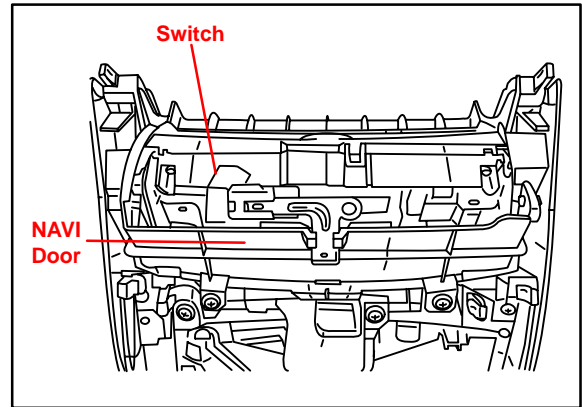
- 2. Locate the NAVI door and switch.

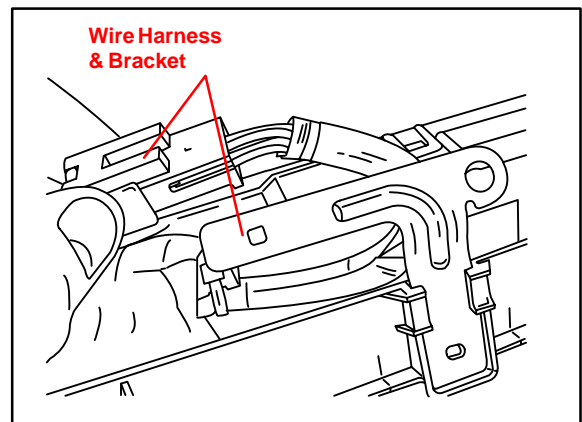
- 3. Remove the wire harness from the bracket.

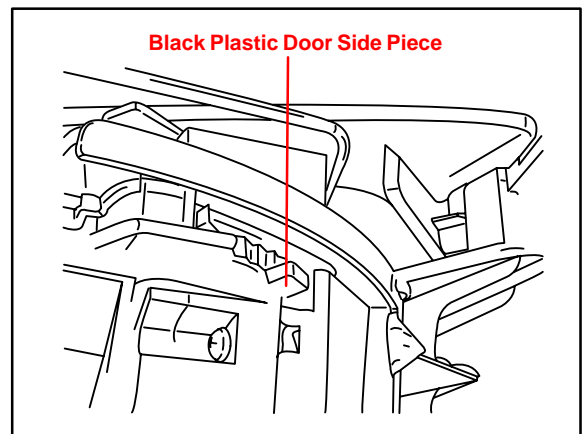
- 4. Insert a pick between the switch and the black plastic door side piece of the door sub-assembly.

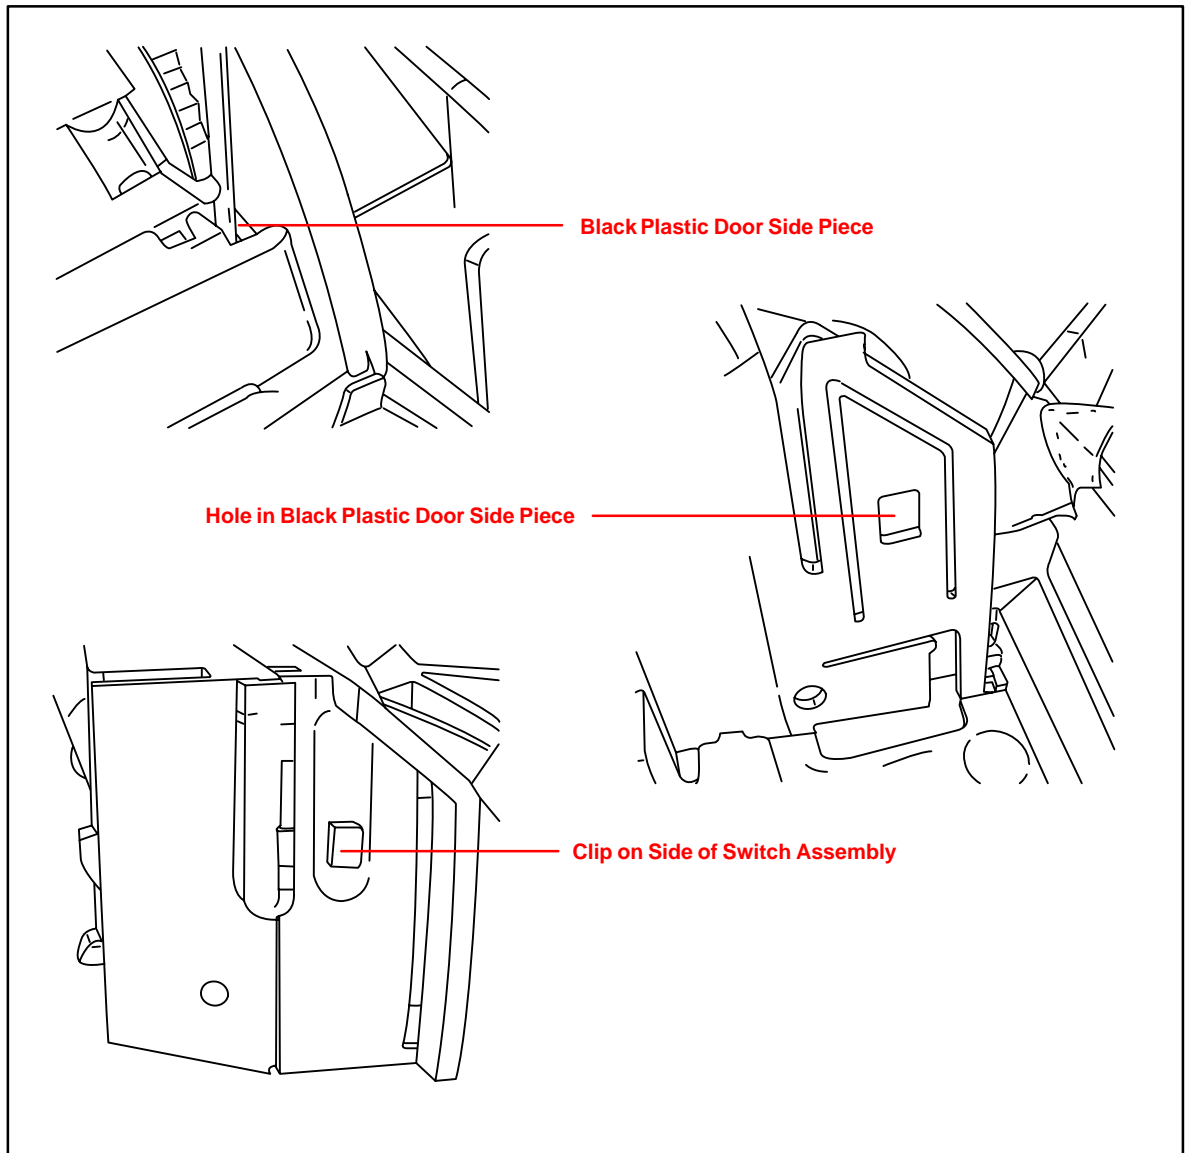
5. Pry the black plastic door side piece away from the switch to release the clip from the hole.

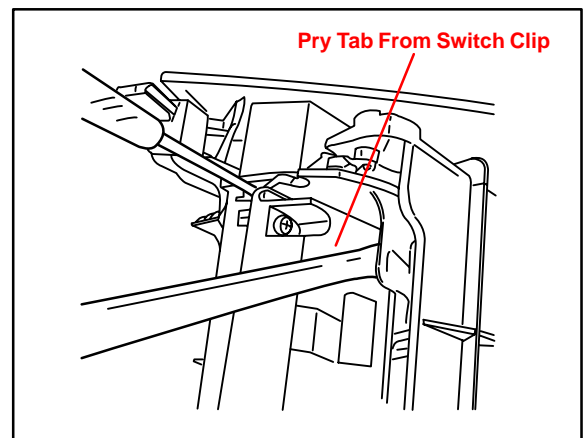
6. Use a screwdriver to pry the tab from the switch clip.  
Pry both sides of the door away from the switch until the switch can be pulled out of the housing.

**NOTE:**  
Repeat steps 3 – 6 on the other side of the switch until both sides are loose.

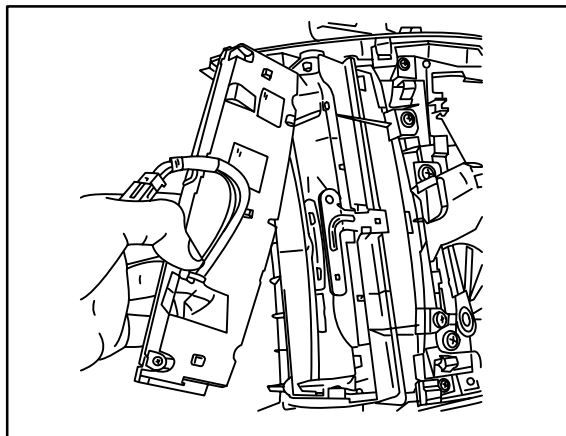
- 7. Remove the NAVI switch from the door assembly.

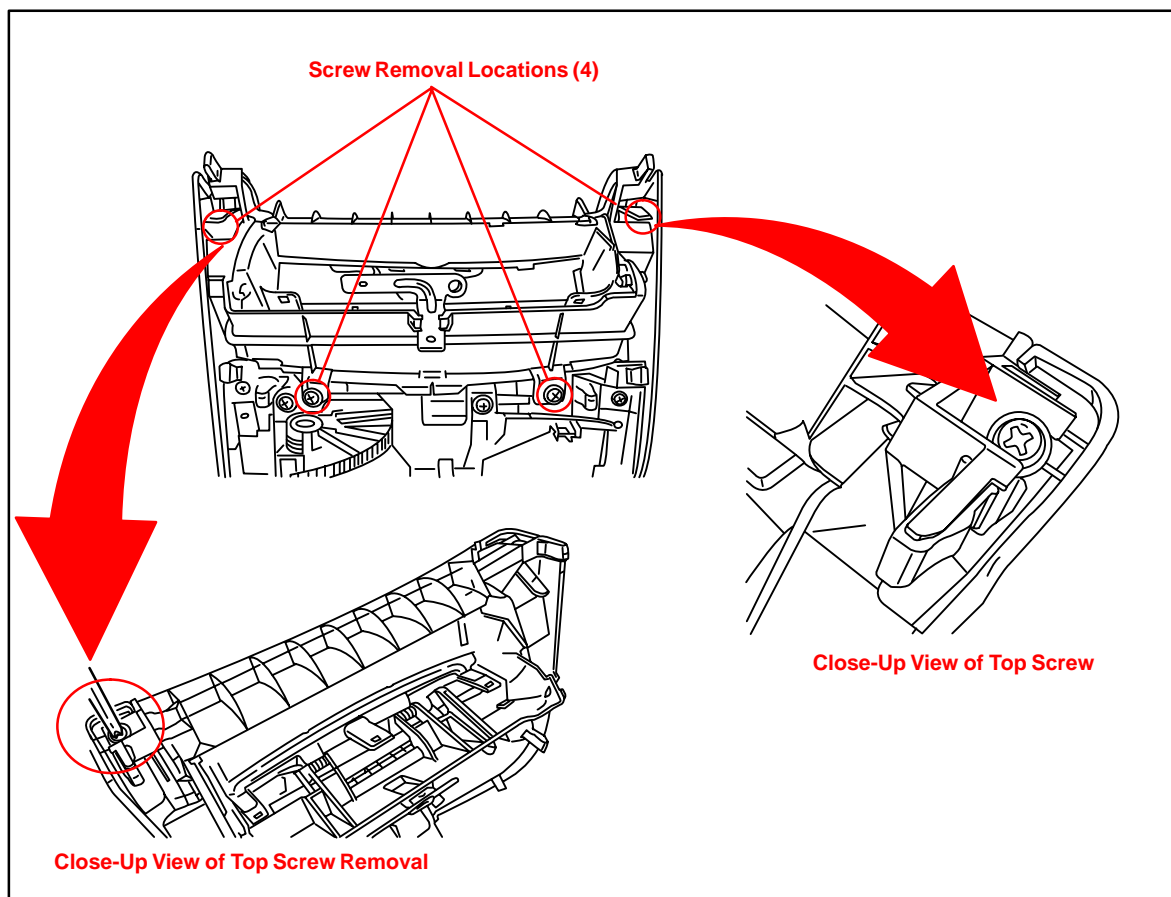
- 8. Locate and remove the four (4) screws.

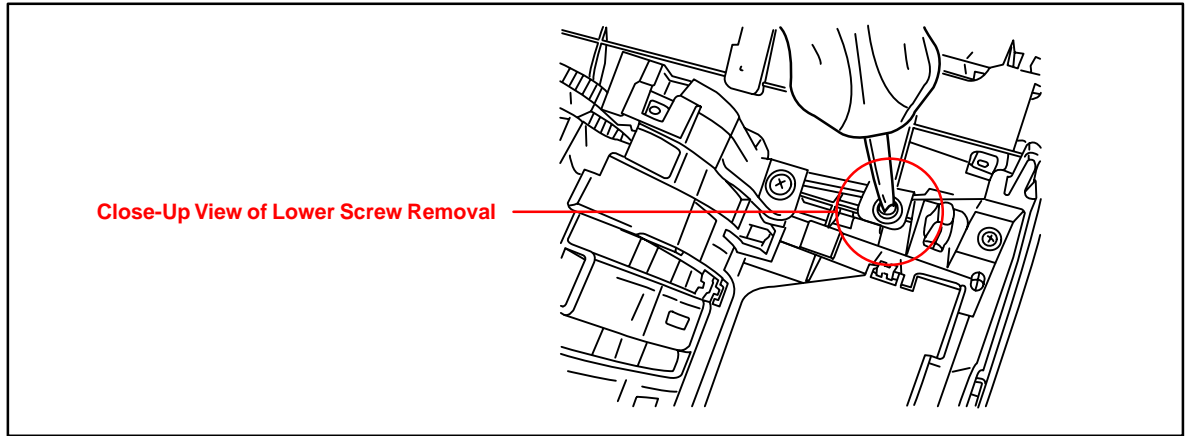
- Remove the two (2) lower screws.

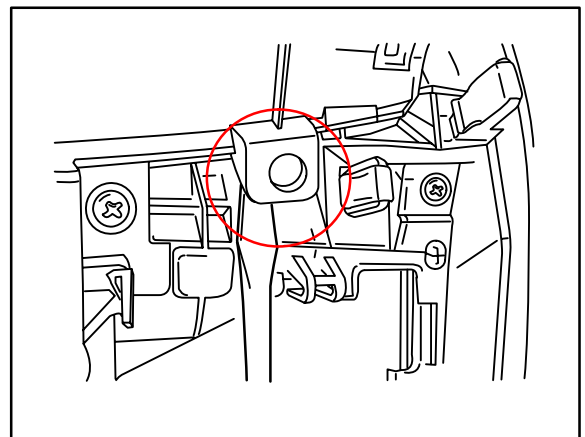
- Use a screwdriver to gently pry up the door tabs.

**NOTE:**  
Only one tab is shown in the illustration.

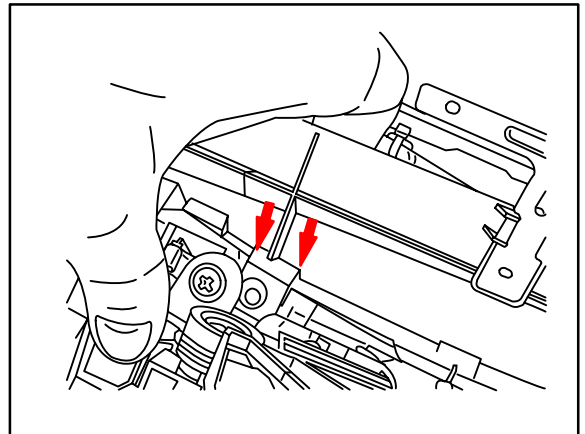
**NOTE:**  
If the left side removal procedure does NOT remove the tab on the left side, grasp the door as shown and pull up on the door until the tab comes loose from the mounting location.

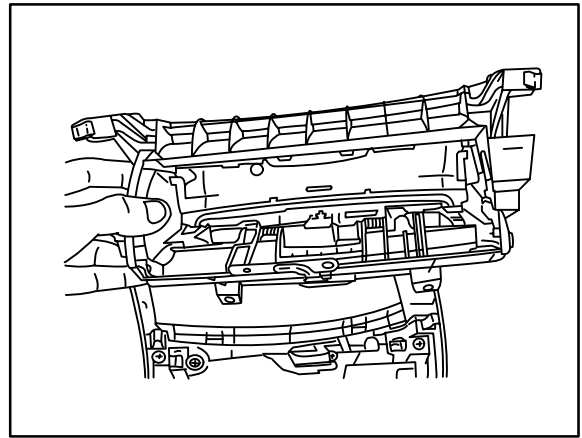
11. Remove the NAVI door sub-assembly from the console sub-assembly.

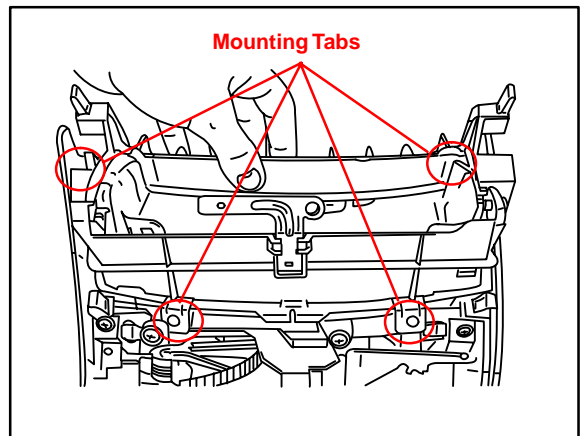
12. Place a NEW NAVI door into the console sub-assembly.  
Confirm all four (4) mounting tabs are properly seated in the housing.

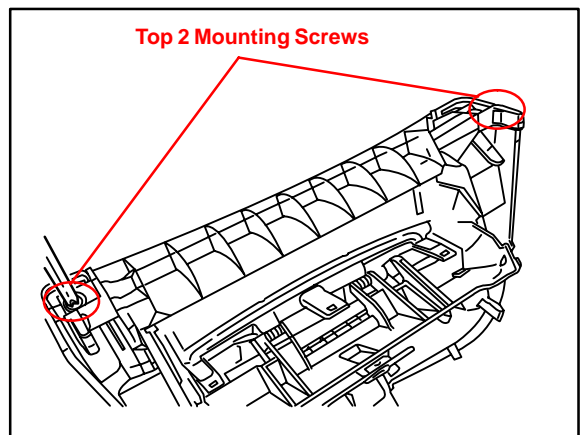
13. Reinsert the top two (2) screws and tighten securely.

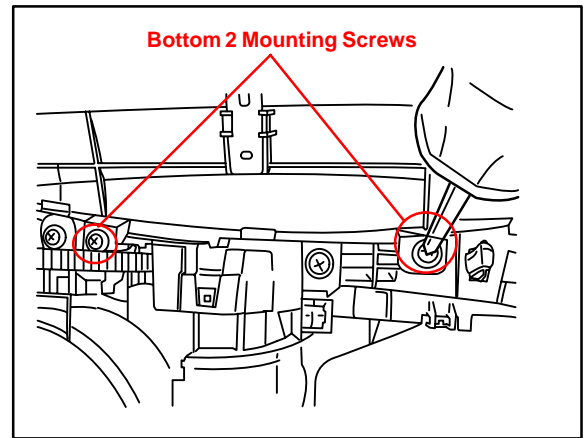
14. Reinsert the bottom two (2) mounting screws and tighten securely.

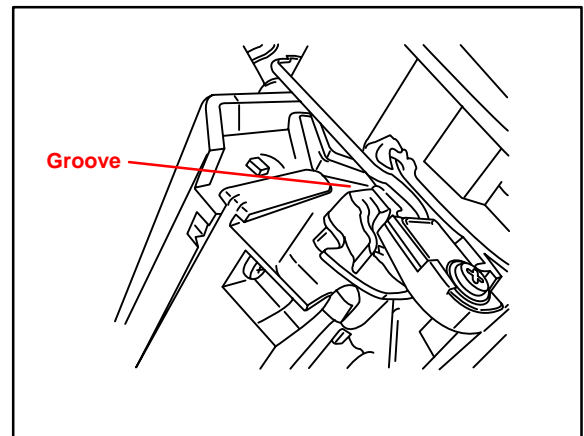
15. Line up the slider on the switch with the groove in the door sub-assembly.

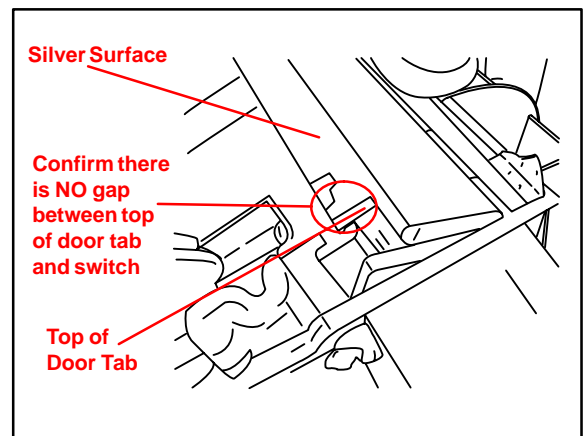
16. Push the switch into the door until the top of the door tab is even with the silver surface.

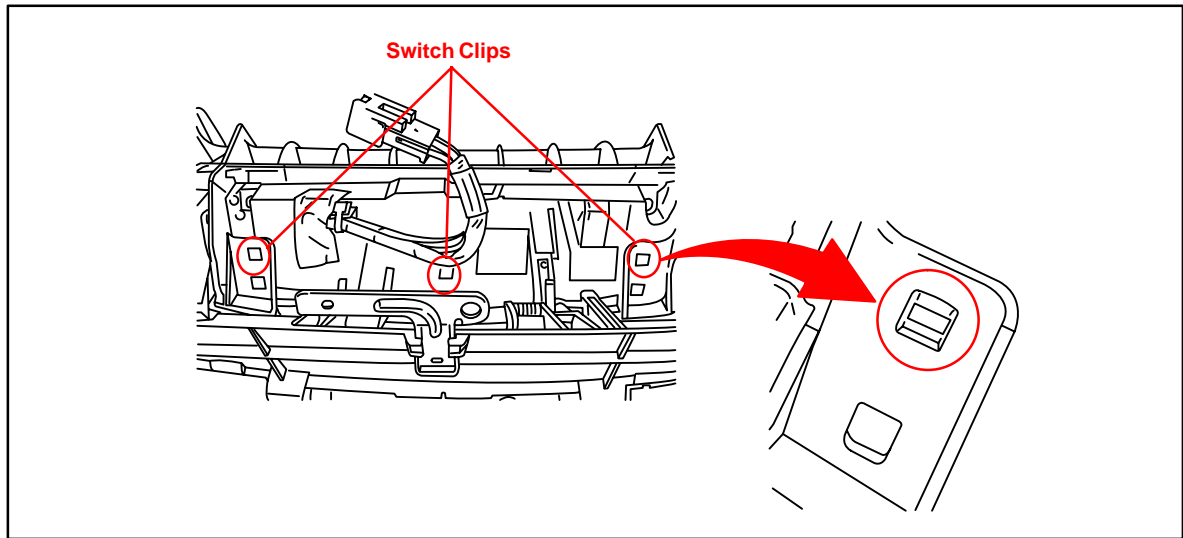
17. Confirm that the switch clips fit into the door tabs as shown.

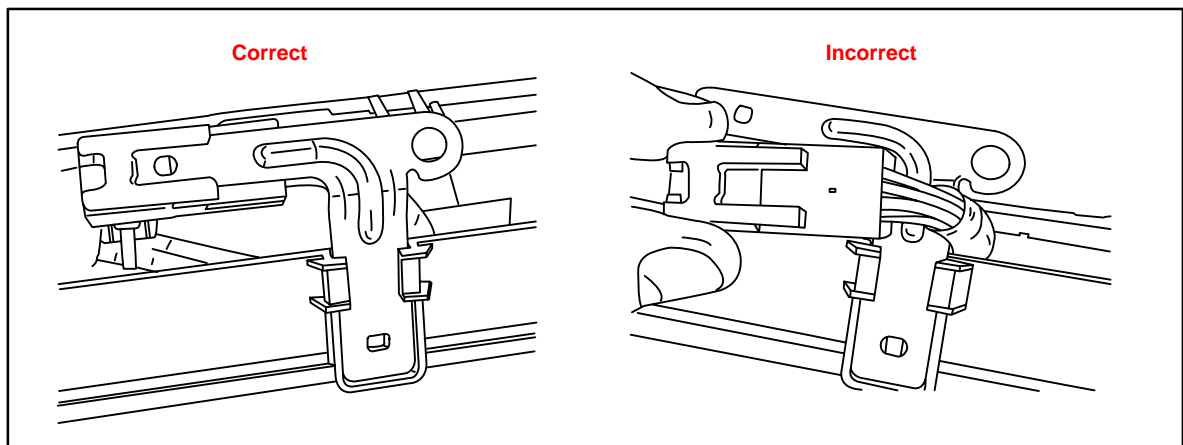
18. Re-attach the wire harness plug onto the metal mounting bracket and confirm the plug opening is in its proper location as shown.
