SERVICE BULLETIN

REFERENCE AUDIO
NUMBER 005
DATE 04-14-89
MODEL '88 & 89, VV

'89 ELECTRONIC TUNE RADIO COMBO ALTERNATOR WHINE NOISE

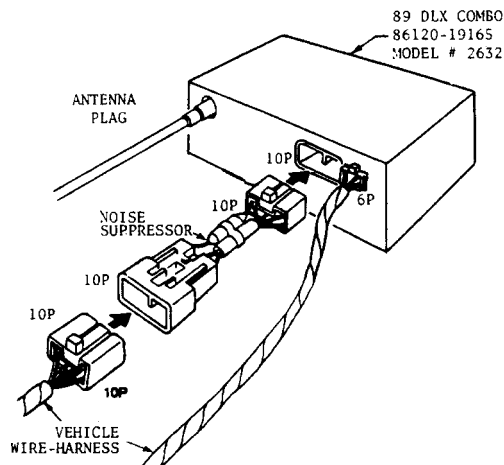
CONDITION: Alternator whine noise may occur in '88 or '89 Camry V-6 with an '89 ETR Combo 4 speaker model 2632 Fujitsu Ten (P/N 86120-19165) installed. This noise will be most noticeable during headlamp operation when playing a cassette tape at low volume listening.

CAUSE: Illumination main power wire static noise from headlamp circuit.

CORRECTION: Install a sub-wire noise suppressor adaptor in-line between the radio unit and the vehicle wire harness as shown below:
