REFERENCE AUDIO
NUMBER 001
DATE 12-23-88
MODEL ALL MODELS

DIGITAL DISPLAY ILLUMINATION '89 MODEL YEAR RADIO

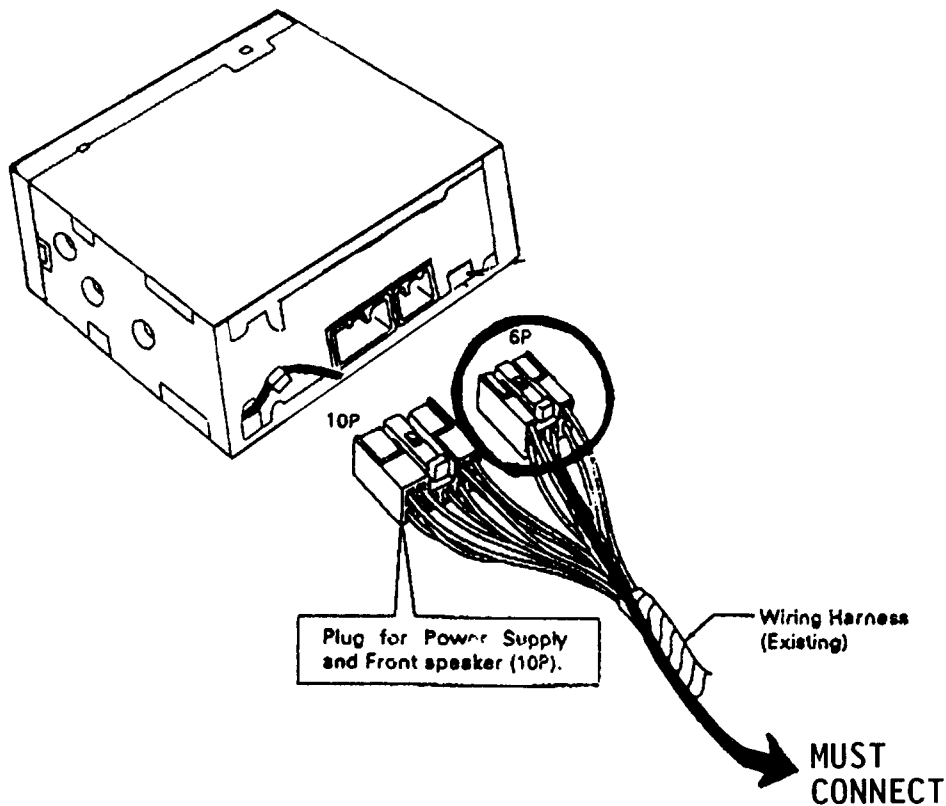
- SYMPTOM:** No illumination on radio chassis P/N 08600-00823 model 6633 when headlights are turned ON.
- CAUSE:** The six pin connector has not been installed. (Please refer to illustration below).
- CORRECTION:** Connect the six pin connector.
