TECHNICAL SERVICE BULLETIN

REF.: AUDIO
NO.: AU92-001
DATE: JANUARY 17, 1992
MODEL: ALL MODELS

1991 PIO/DIO AUDIO 11201/74100 CUTS OUT DURING CASSETTE MODE

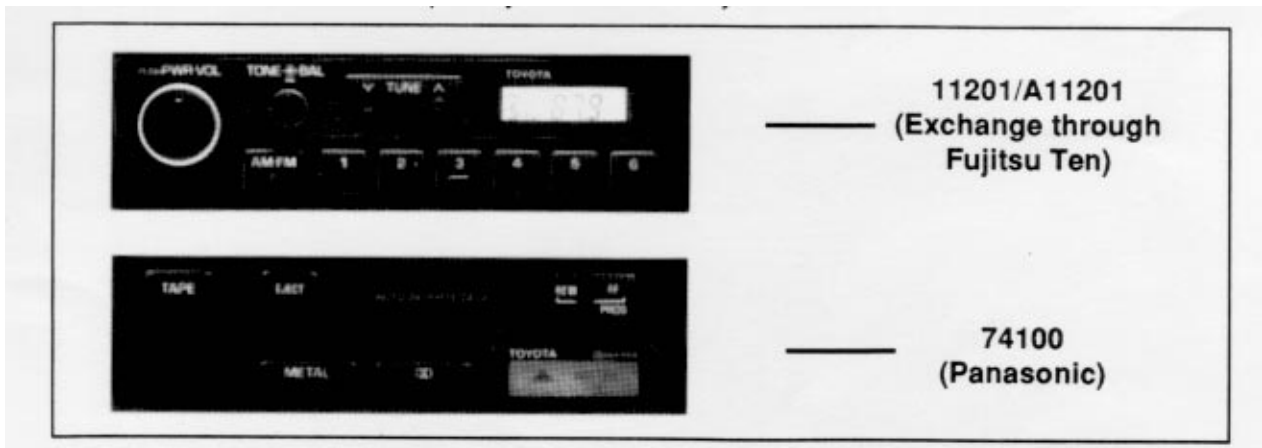
Sound intermittently "cuts out" cassette mode on 1991 vehicles equipped with 11201 PIO/DIO 2 speaker ETR radio and 74100 PIO/DIO cassette player combination. This condition occurs most frequently in cold and dry climates.

Exchange the 11201 2 speaker ETR through Fujitsu Ten's warranty exchange program. All exchange radios have been countermeasured effective 11/06/91. Countermeasured 11201 radios will have a "black" mark on the volume shaft (remove the volume knob to verify marking).

Countermeasure is effective **only** when sound intermittently "cuts out" during cassette mode with the 11201/74100 combination. If the cassette player has no sound, check the "D/P" switch to make sure it is set in the "P" position.
