# TECHNICAL SERVICE BULLETIN

REF.: AUDIO  
NO.: AU92-005  
DATE: OCT. 30, 1992  
MODEL: ALL MODELS

## '92 FUJITSU TEN 34210/34212 PIO/DIO CD PLAYER

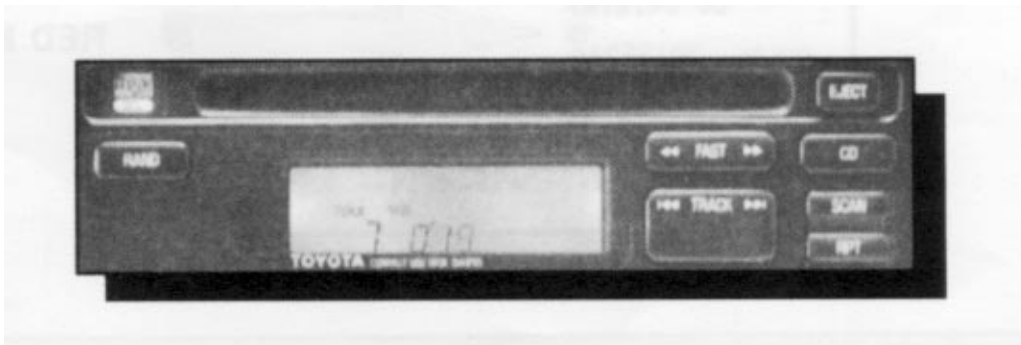
### '92 Fujitsu Ten 34210/34212 PIO/DIO CD Player

CD player will not accept or does not eject CD.

Lever in the CD mechanism become misaligned causing the mechanism to jam during loading/eject operations.

Exchange the CD player.

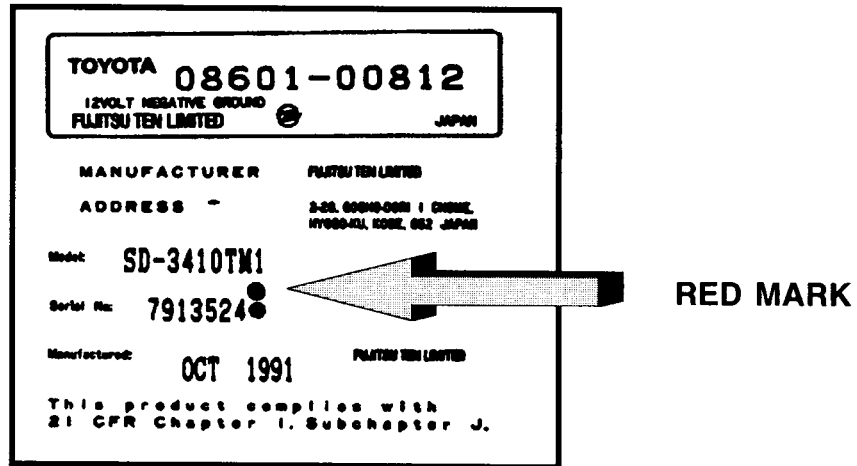
Exchange CD players which have been countermeasured can be identified by a **RED MARK** next to the Serial Number on the bottom of the CD player. Fujitsu Ten started shipping countermeasured exchange CD players starting 6/92.
