**Technical Service
BULLETIN**

**REAR HVAC VENTS BLOW HOT AIR
WITH A/C "ON"**

'05 - '07 Avalon

AC002-08

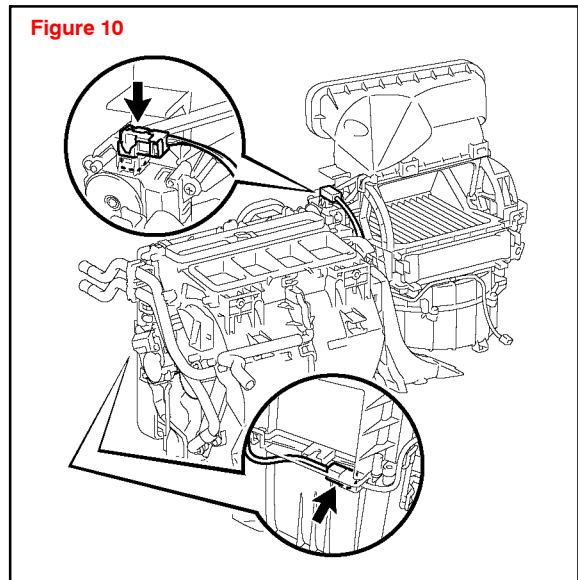
- C. Connect the wire harness and install the connector and clamp.

10. Install the No. 2 air duct sub-assembly by engaging the 2 claws.
