## 2AZ-FE Throttle Body

**Service Category** Engine/Hybrid System

**Section** Engine Control

The purpose of this TSB is to provide updated throttle body part number information for certain vehicles equipped with the 2AZ-FE engine. The drain pipe has been eliminated on throttle body service parts. Please use the information below when replacing the throttle body assembly.

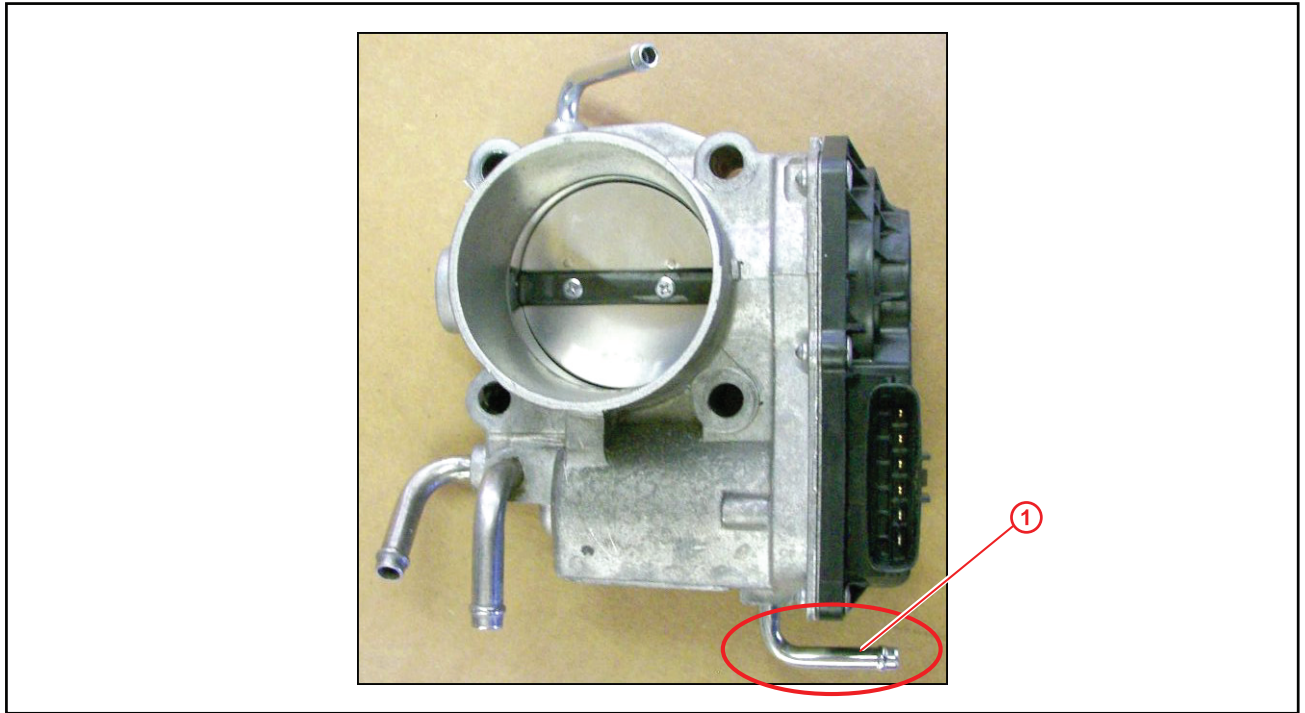
**Figure 1. Previous Throttle Body Assembly**

<b>1</b>	This Port NOT on New Service Part
----------	-----------------------------------

When replacing the throttle body assembly, remove and discard the throttle body hose that no longer has a port on the throttle body assembly. The port connected to the other end of the throttle body hose can be left open to the atmosphere — it does NOT need to be sealed.
