# TECHNICAL SERVICE BULLETIN

**REF.:** AUDIO  
**NO.:** AU92-002  
**DATE:** AUGUST 14, 1992  
**MODEL:** ALL MODELS

## 74100 PANASONIC CASSETTE PLAYER WON'T PLAY

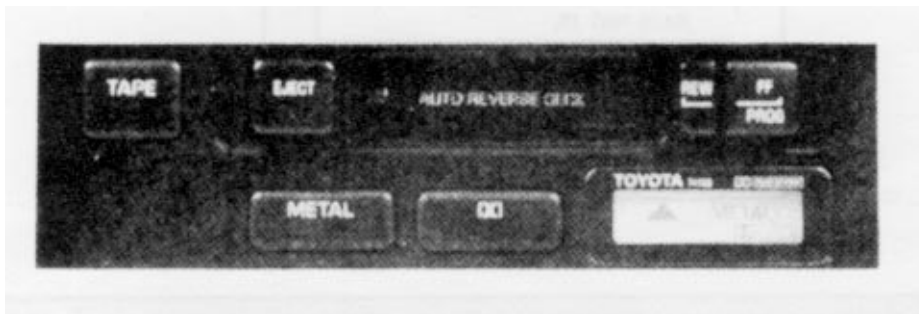
### Panasonic 74100

Cassette will load, fast forward/rewind and eject, but will not play on Panasonic 74100 cassette player (P/N 08690 – 008818). The motor is operating, but there is little or no audio output.

Gear mechanism which controls the tape head becomes inoperative, preventing the tape head from contacting the cassette tape.

The gears controlling the tape head have been changed to improve durability.

If a customer complains of this condition, exchange the cassette player through Panasonic's exchange system.

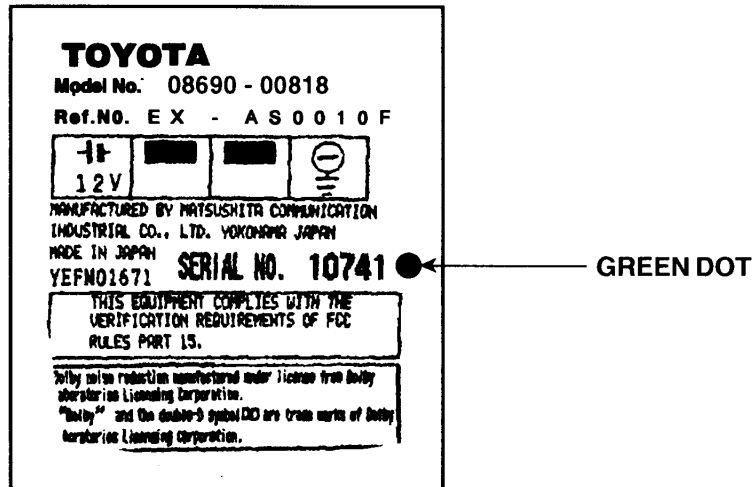
Exchange units have been countermeasured starting 12/91 and will have a **GREEN DOT** after the serial number.
