SERVICE BULLETIN

REFERENCE	TRANSMISSION & CLUTCH
NUMBER	017
DATE	09-29-89
MODEL	SV, ST, AW with A140E

A14#E VALVE BODY STRAINER

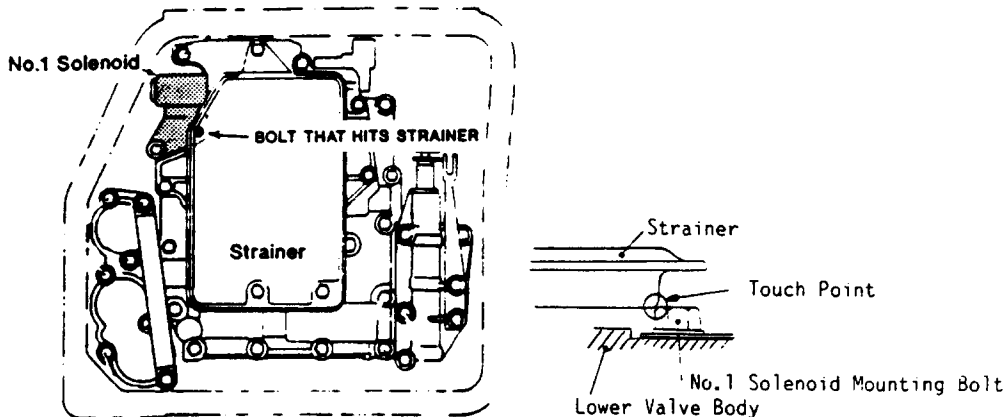
When replacing the Valve Body Strainer (P/N 35330-20011) on vehicles equipped with the A14#E A/TM, you may encounter contact between the strainer and the number 1 shift solenoid mounting bolt (see illustration).

NO.1 SOLENOID MOUNTING BOLT
INTERFERES WITH NEW STRAINER
P/N 35330-20011 INSTALLATION
