**Technical Service  
BULLETIN**

Title:  
**ACCESS DOOR WATER LEAK**  
Models:  
**'07 FJ Cruiser**

**BODY**  
**B0007-07**

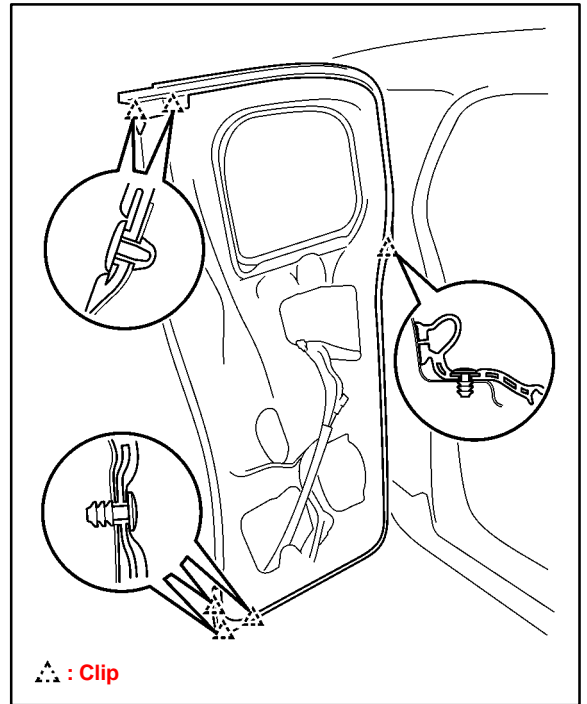
1. Remove the access panel weatherstrip.
  - A. Disengage the 7 push clips.

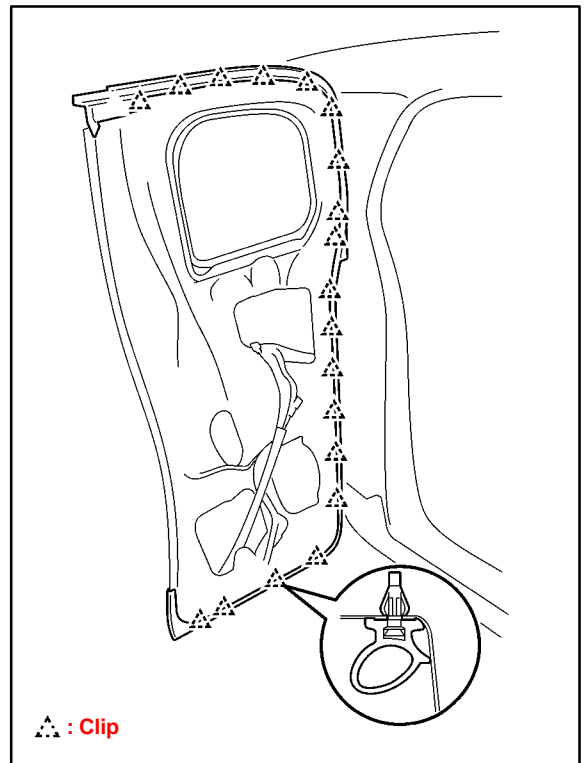
- B. Using the plastic panel clip removal tool, disengage the 19 clips on the weatherstrip.

**NOTE:**  
Remove any tape remaining on the door side.

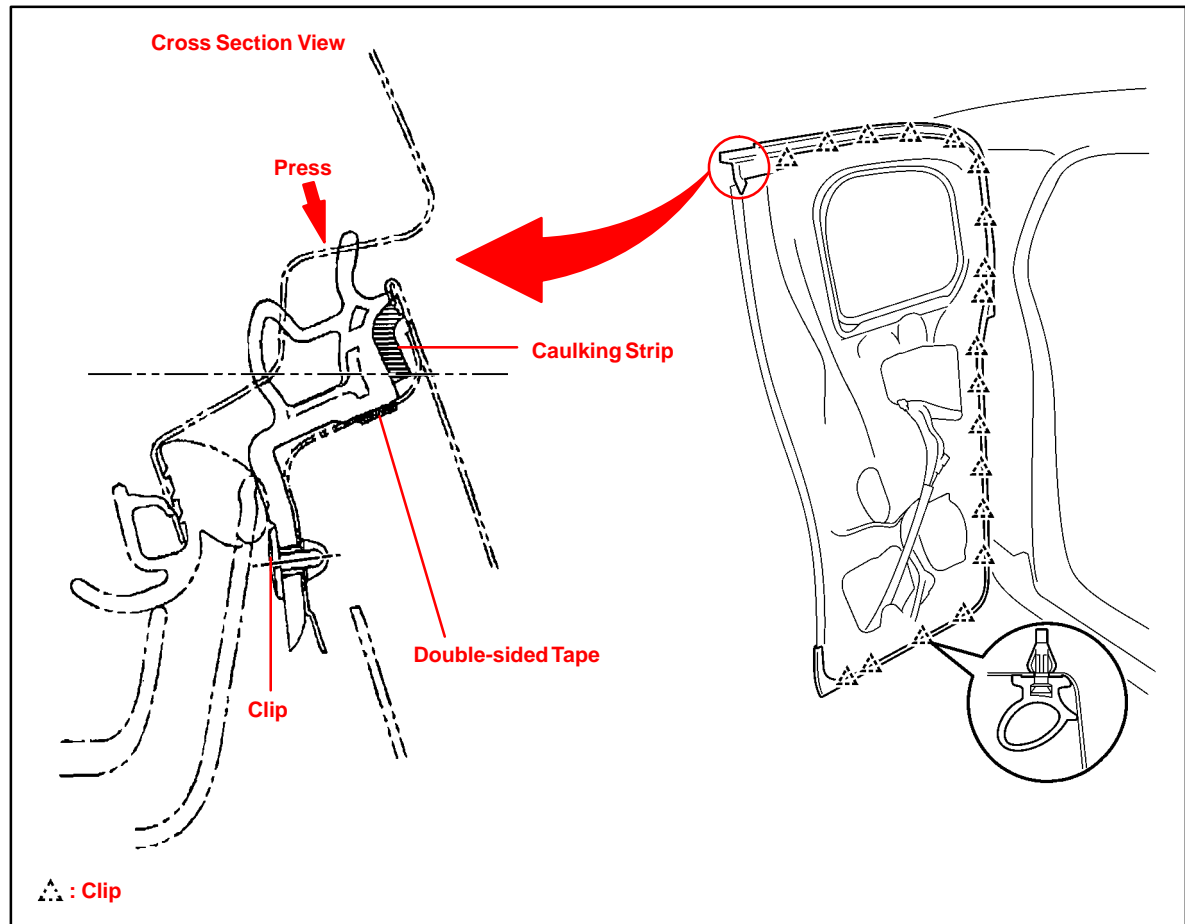
2. Install the access panel weatherstrip using the NEW service parts.
  - A. Clean the door surface where the double-sided tape is applied.
  - B. Engage the 19 clips.
  - C. Push firmly on the weatherstrip to ensure the double-sided tape makes good contact with the door frame.

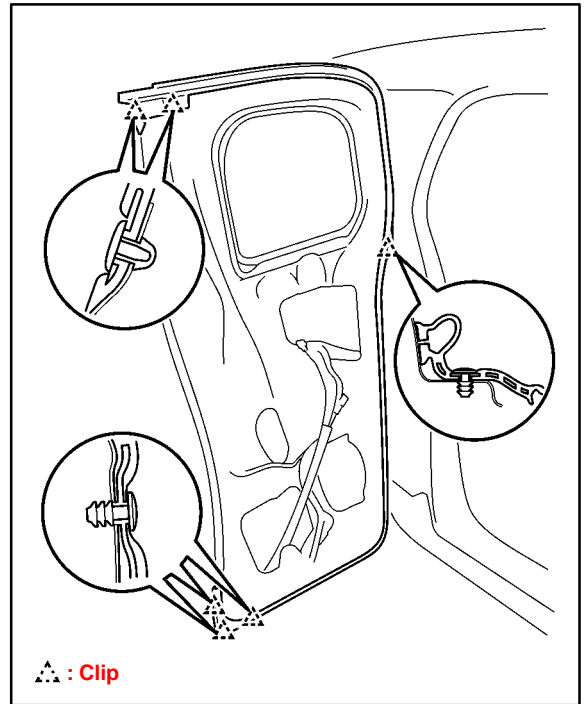
D. Engage the 7 push clips.
