Technical Service BULLETIN

Title: **AUDIO SYSTEM MUTED AFTER ENDING BLUETOOTH WIRELESS PHONE CALL**

Models: '04 Land Cruiser

AUDIO
AU003-04

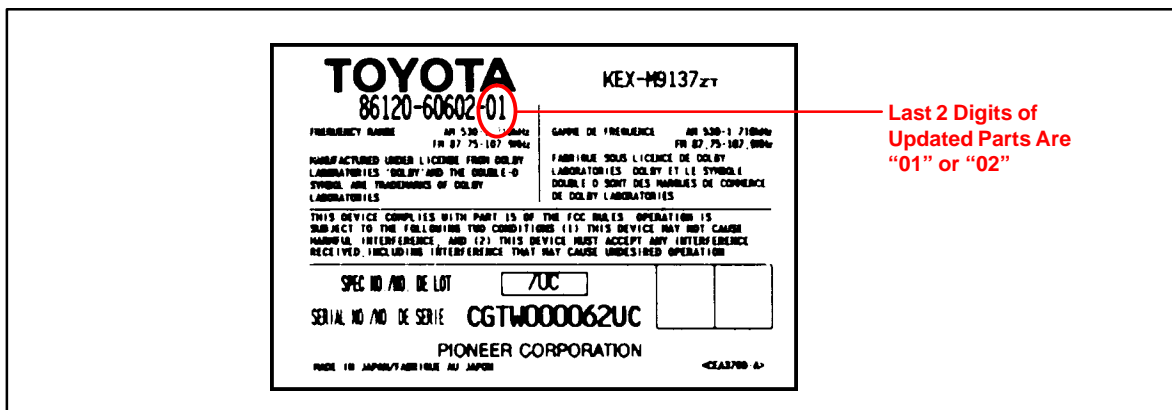
Parts Identification The updated parts will have a 2 digit number (01 or 02) after the Toyota part number on the tag on the bottom surface of the head unit.

Repair Procedure Order a replacement radio head unit from Pioneer through the exchange program by calling 1-800-553-3756.
