SERVICE BULLETIN

NUMBER 004 (REVISED)

MODEL 89 AE, EL, SV/VV,
ST, YR, RN, VN, FJ

AUTO REVERSE CASSETTE (P/N 08690-00810) MODEL 5906 INSTALLATION

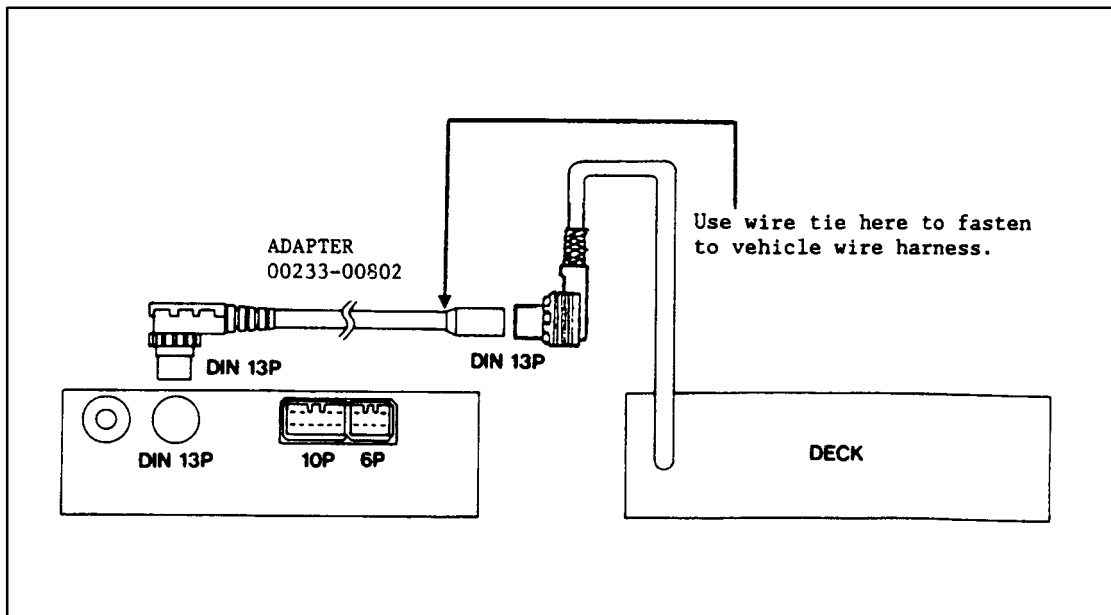
Once connections have been made, use a plastic tie strap or electrical tape to fasten the 13 pin DIN connector adapter cable to the vehicle wire harness (see figure on page 2).

Due to the possibility of improper locking of the DIN connector, there is the chance for a loose connection on units installed prior to this notice. If this occurs, the radio and cassette deck units will become inoperative.

An adapter cable (P/N 00233-00802) is now required to ensure proper locking of the DIN connector.

- 1) Verify that the applicable radio and cassette deck units are installed (ie., model 1432, A1432, 1433, or A1433 AM/FM ETR with model 5906 Cassette Deck).
- 2) Install adapter cable P/N 00233-00802 as shown on the figure below.
