Technical Service BULLETIN

FRONT SEAT TRACK SQUEAK

'03 4Runner

NV001-03

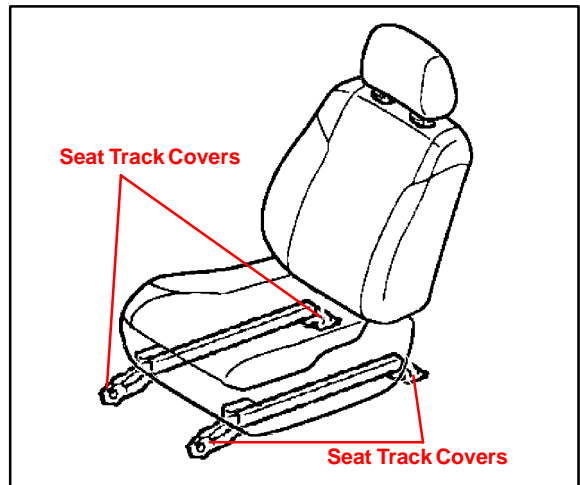
1. Remove seat track covers.

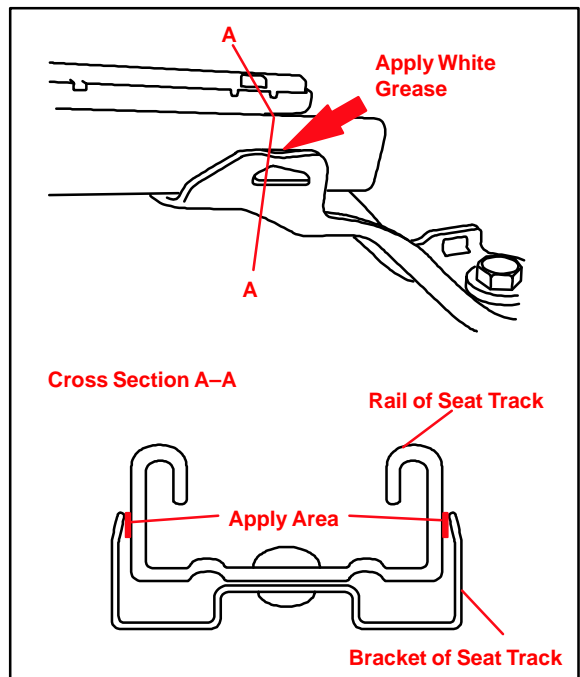
2. Apply white grease between the seat track rail and bracket as shown.

- When applying lubricant to the seat track, cover the carpet with paper or sheet plastic to protect from over spray.
- There are a total of 8 apply areas. Two at the front and two at the rear of each of the two seat tracks.
