TOYOTA Technical Service BULLETIN

MODIFIED REAR CUP HOLDER

'98-'99 Land Cruiser

BODY
BO006-99

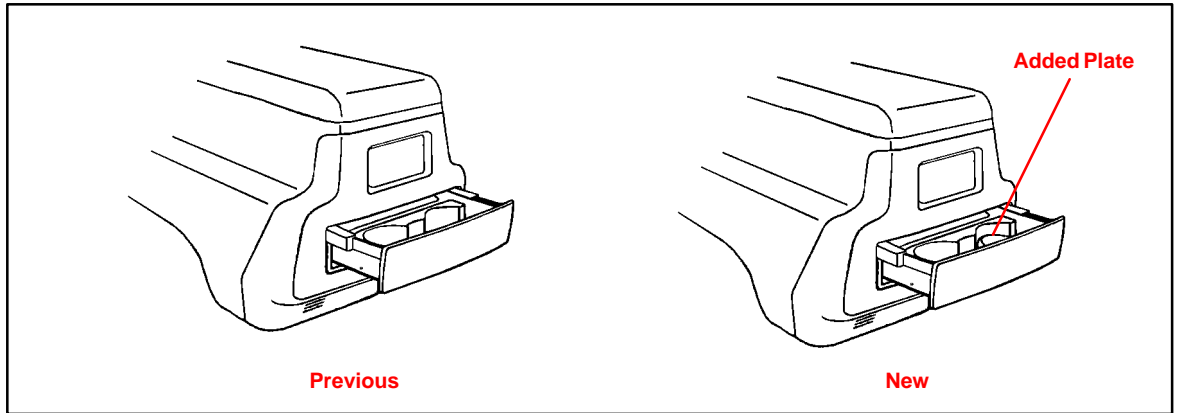
Introduction A plate has been added into the Rear Cup Holder and Console Rear End Panel of the Land Cruiser to increase rigidity of this area.
