**Technical Service
BULLETIN**

Title:
**REAR WIND DEFLECTOR
INSTALLATION NOTE**

Models:
'98 Land Cruiser

ACCESSORY
AX001-98

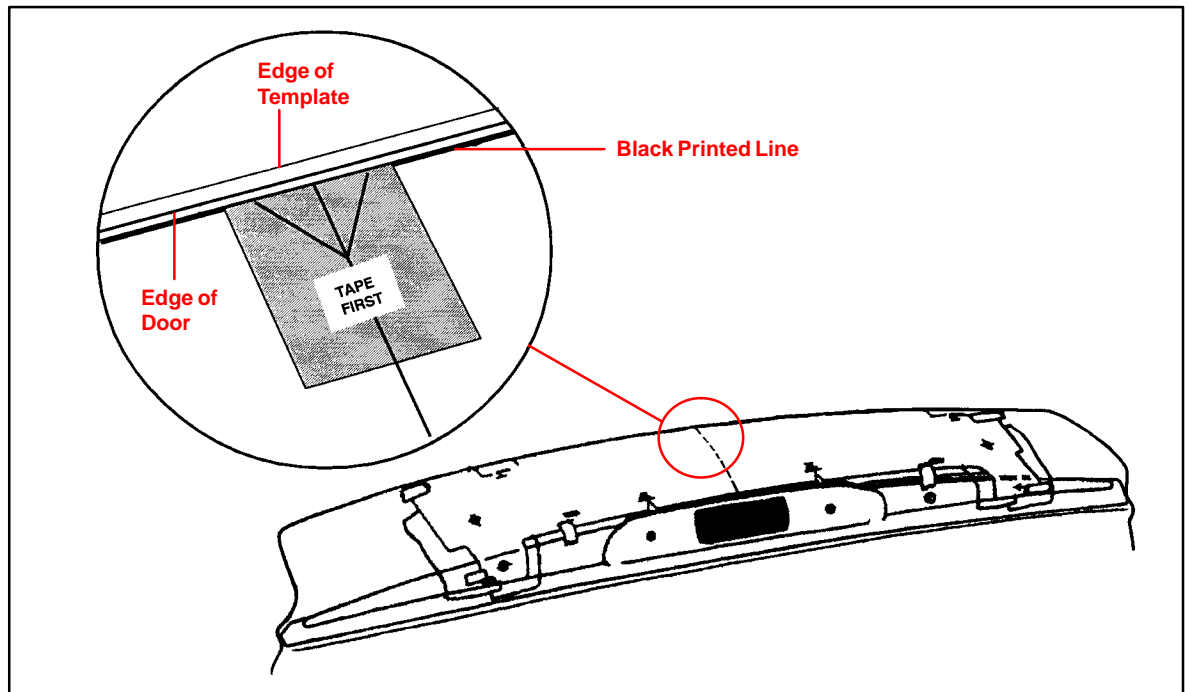
Change to Procedure Page 2, step 7 of the installation instructions *should* state: "Make sure the black printed line on the template lines up with the front edge of the door."

NOTE:
Do not line up edge of plastic template to edge of door.
