**Technical Service
BULLETIN**

SEAT CUSHION HEIGHT ADJUSTMENT HANDLE IMPROVEMENT

'03 – '04 4Runner

BODY
BO013-04

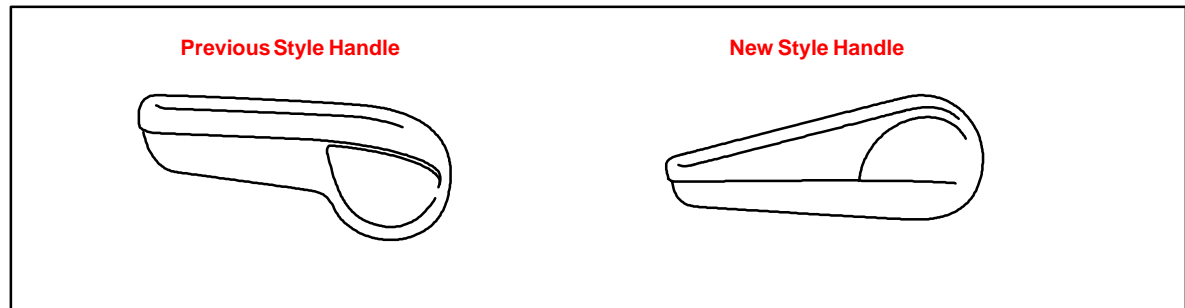
Introduction Some 2003 and 2004 model year 4Runner vehicles may experience a condition where the seat cushion height adjustment handle is contacted while entering or exiting the vehicle causing the seat adjustment to change. A new seat cushion height adjustment handle has been developed to correct this condition.

PREVIOUS PART NUMBER	CURRENT PART NUMBER	COLOR	PART NAME	QTY
72459-60010-B1	72459-60020-B1	Stone	Cap, Vertical Seat Adjusting Knob	1
72459-60010-B2	72459-60020-B2	Dk. Gray		
72459-60010-E0	72459-60020-E0	Fawn		
72493-60010-B1	72493-60020-B1	Stone	Handle, Vertical Adjusting, No. 2	1
72493-60010-B2	72493-60020-B2	Dk. Gray		
72493-60010-E0	72493-60020-E0	Fawn

- B. Remove the 2 screws and the seat cushion height adjustment handle.
2. Replace the seat cushion height adjustment handle with a new service part.
3. Installation is the reverse order of removal.

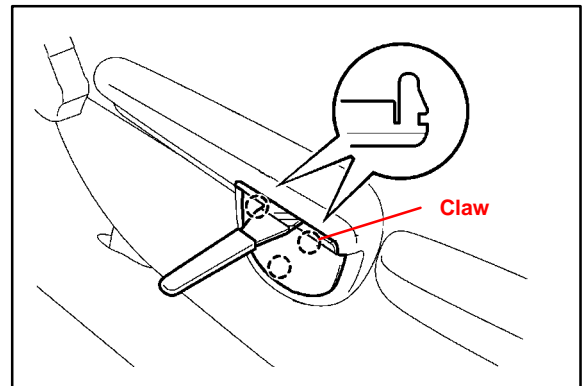
1. Remove the seat cushion height adjustment handle No.2.
 - A. Using a screwdriver, disengage the 3 claws and remove the seat cushion height adjustment handle LH.

Tape the screwdriver tip before use.
